Independent Home Inspection LLC

Building Inspection Report

123 Sample Road, Bedford Hills, NY 10507
Inspection prepared for: John Smith
Date of Inspection: 10/31/2015 Time: 1 PM
Age of Home: 2014 Size: 8406
Weather: 60s sunny

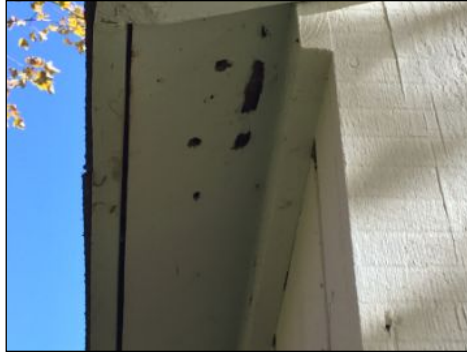
Location: Pool house

Observations: There are small holes and openings at the exterior from wood boring bees which appears currently inactive due to time of year. Recommend repairing and or sealing openings, and maintaining finish to deter future damage. If activity occurs exterminate as needed, bees may return at spring time.

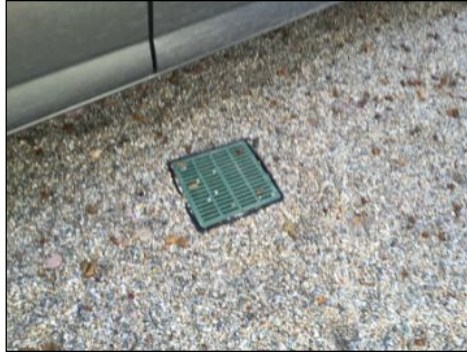
Observations: There is an area drain that will be subject to contamination by dirt, which should be periodically monitored and kept free of dirt.

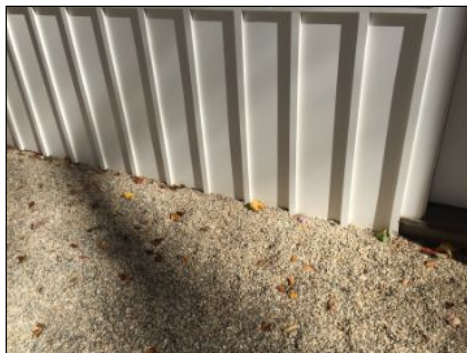
Observations: Areas of the grading at the siding is equal to the wall covering which is conducive to moisture intrusion, rot, and wood destroying insects. Recommend creating a clearance to wall covering, current standards is 6" minimum ground clearance to wall covering.

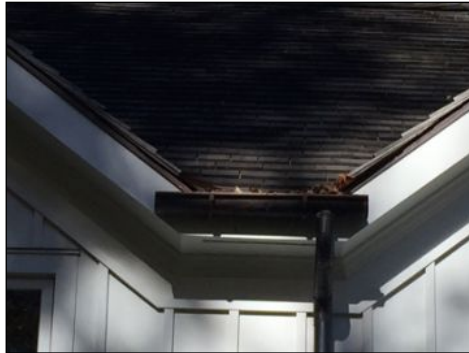
Observations: The general design of the valley is conducive to moisture intrusion and overwhelming of the gutters during heavy rains and should be monitored and improved as needed.

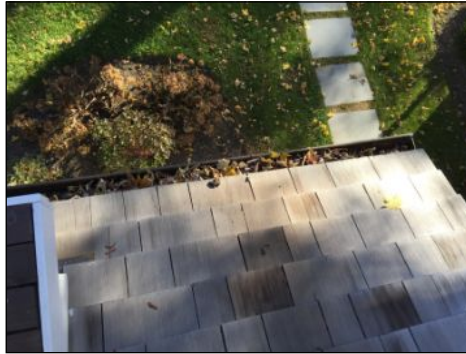
Areas of gutter are overflowing splashing on the building.

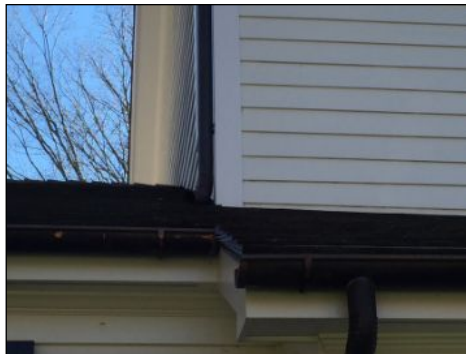
Observations: Some downspout are draining water on the lower roof creating a conducive condition to deterioration and moisture intrusion, recommend extending downspout to lower gutter or ground instead of dumping the roof surface.

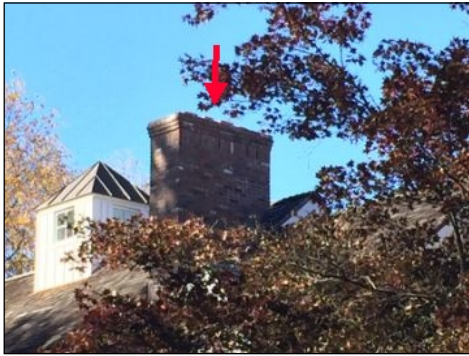
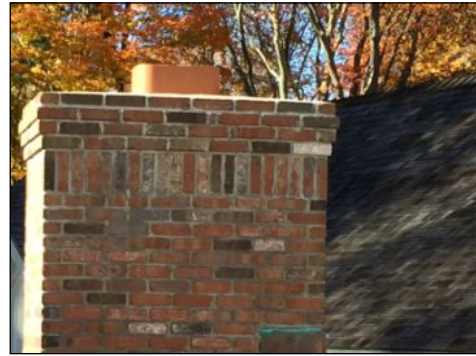
Observations: The chimney lacks a weather caps on the chimney flues and as they prevent moisture intrusion and thereby extend the life of the chimney, recommend installing weather caps.

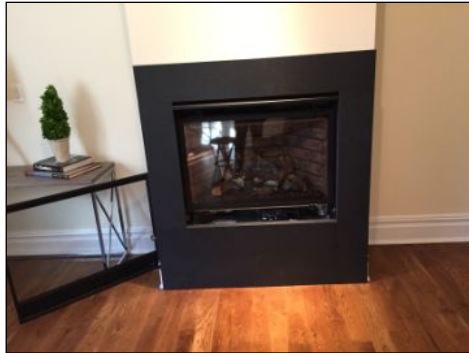
Gas fireplace trim surround is incomplete.

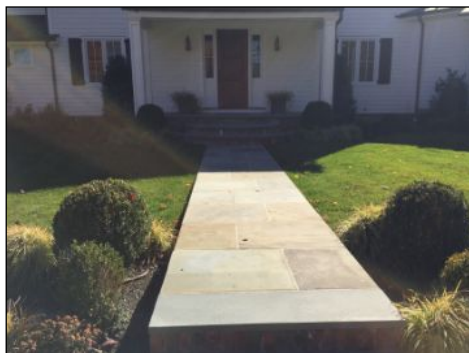
Observations: Stairways lack a handrail which should be installed.

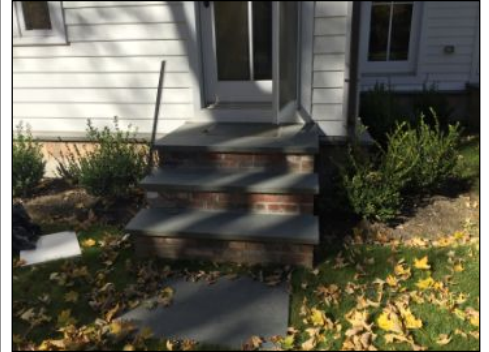
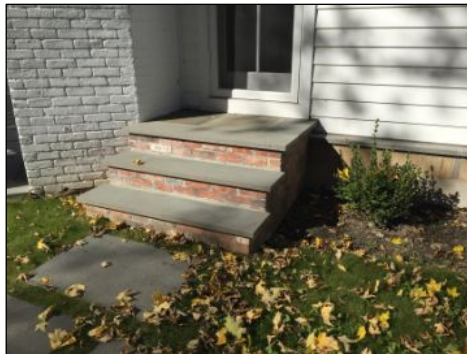
Observations: Stairways lack handrails which should be installed.

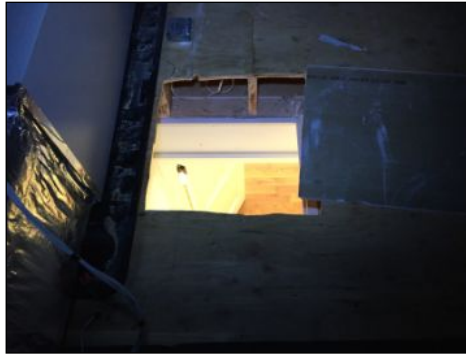
Right side upper access hatch opening framing is incomplete which needs repair.

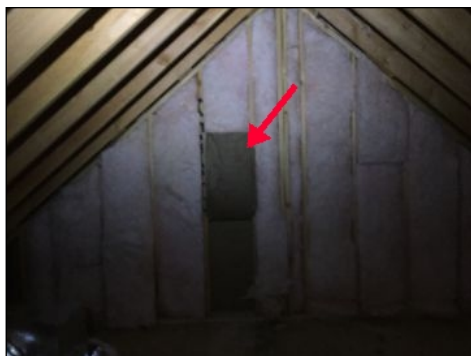
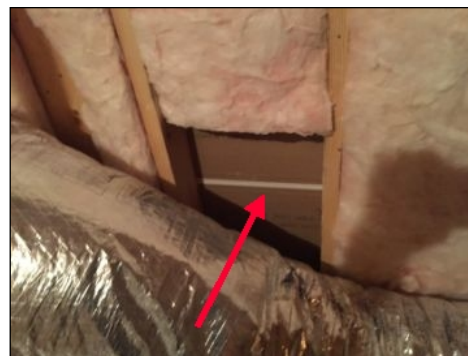
There are some sections of insulation that have been removed or adjusted which should be replaced.

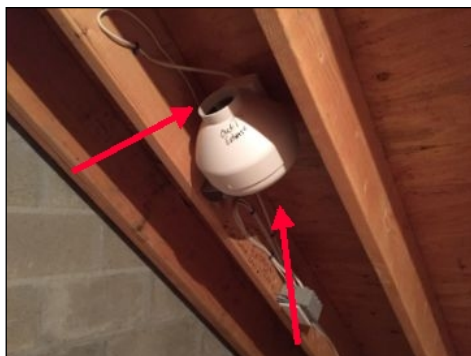
Master bathroom exhaust fan lacks ducting which needs completion to ventilate bathroom.

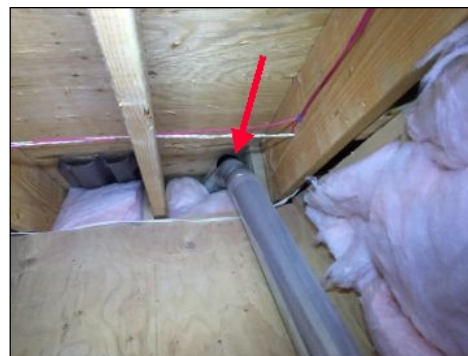
Observations: A section of ducting is separated in the attic and needs repair.

A section of ducting is separated in the attic and needs repair.

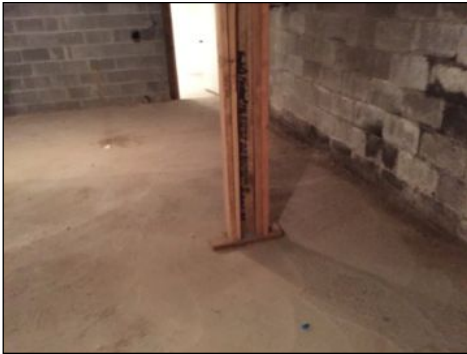
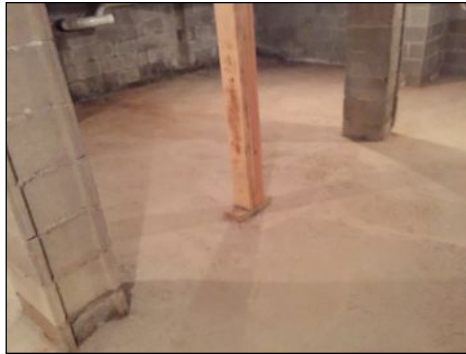
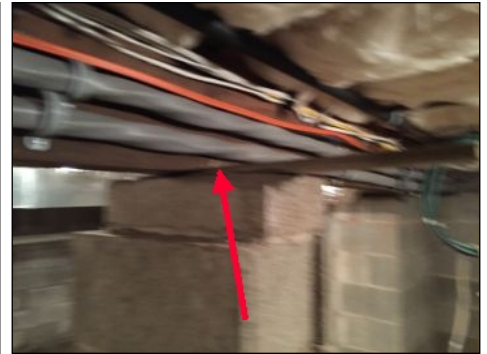
Wood columns or supports have been added left side of the building in the basement which appear to lack proper footings that need further evaluation and repair to ensure adequate support.

Nonprofessional shimming is present on column supporting the beam which is crushing that needs repair.

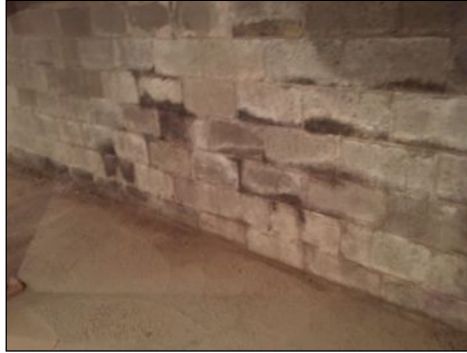
The basement could be subject to moisture intrusion, and the presence of salt crystal formations and staining on the basement walls and floor confirms that some moisture does reach this area. Therefore, you should keep any storage items isolated from the walls and floor, monitor the basement during heavy rains.

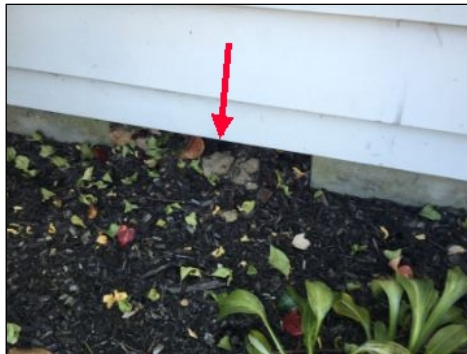
Crawlspace vents front of the building are at or below grade and prone to moisture intrusion which need re grading or vent well to prevent moisture intrusion.

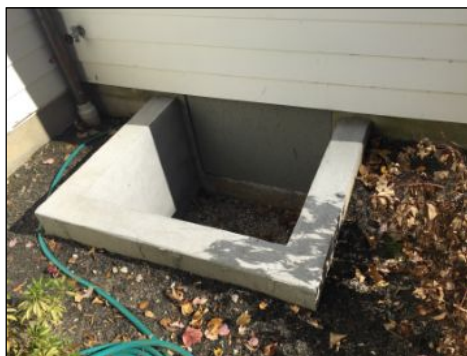
Observations: Recommend access cover to to ensure water tightness.

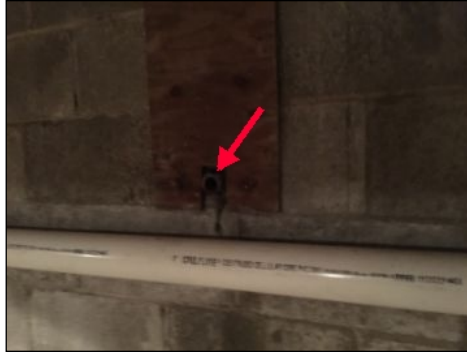
Location: Back of the building, Basement

Observations: Foundation opening from previous mechanical system needs repair to prevent moisture intrusion.

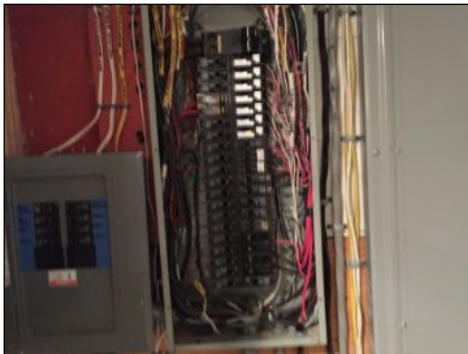
Arch fault indicator light is on indicating problem which needs further evaluation and repair by electrician.

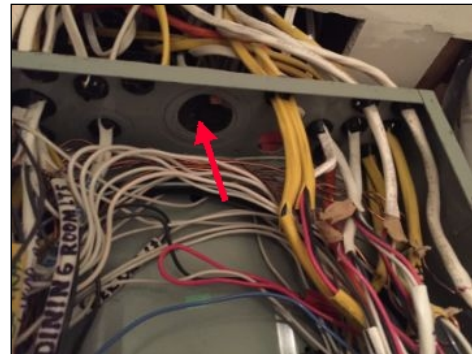
There are open knockouts in the panel box which need repair or cover.

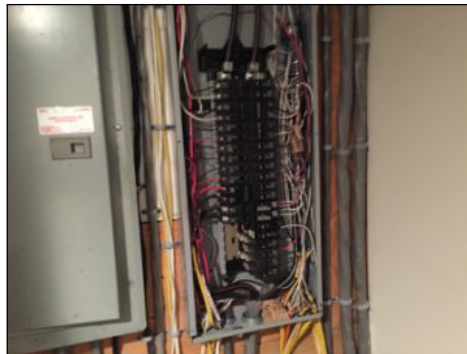
Panel lacks main disconnect at panel which should be installed.

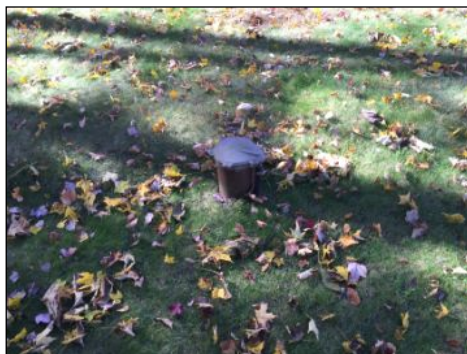
Well cap is loose and needs securing.

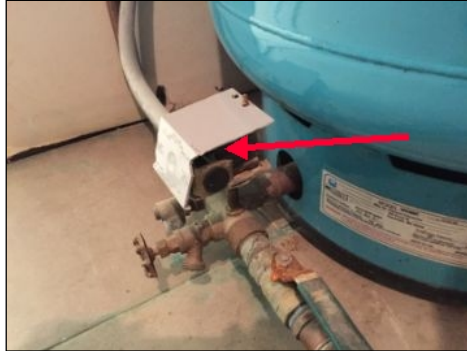
Observations: Pump switch lacks proper cover resulting in exposed connections which is a safety hazard that needs repair.

Pump switch lacks proper cover resulting in exposed connections which is a safety hazard that needs repair.

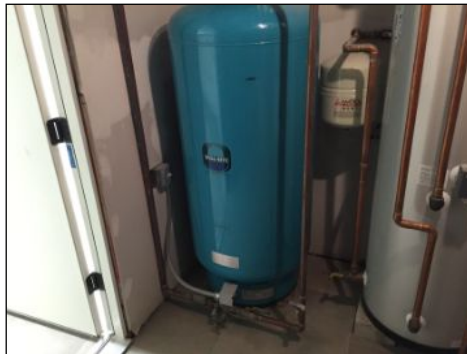
Recommend insulating pressure tank to prevent condensation.

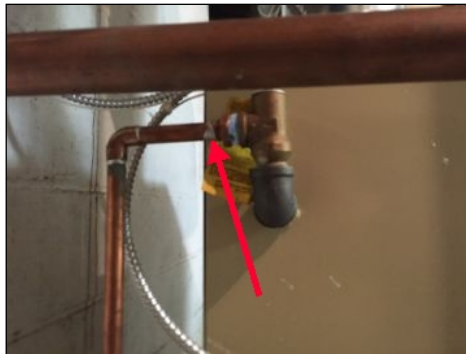
Valve discharge piping has been improperly reduced to 1/2" piping which needs repair to include 3/4" piping.

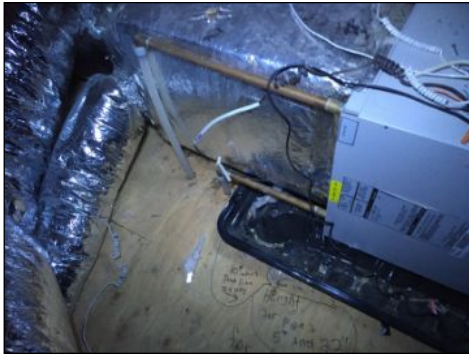
Recommend insulating hydro air heating supply and return lines in the attic.

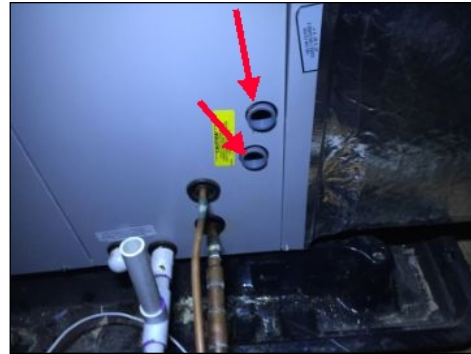
There are open ports drawing in air which should be plugged.

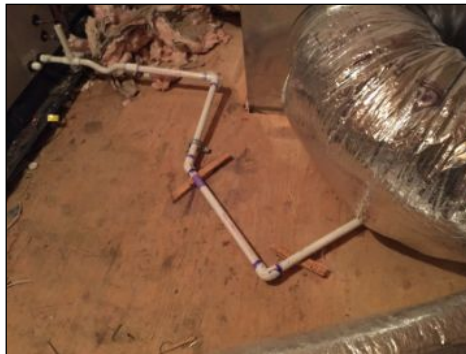
Observations: **Condensate drain line is improperly plumbed and pitched which needs re piping by air conditioning contractor to ensure proper drainage.**

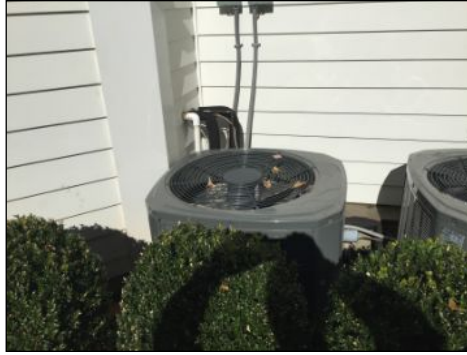
Observations: Condenser lacks proper manufactures recommended clearance from other condenser and wall which needs further clearance created to ensure adequate air flow.

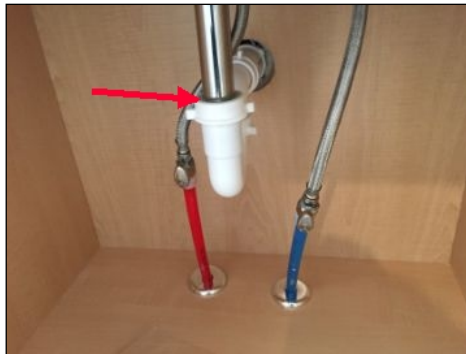
Observations: Drain line is leaking and needs repair.

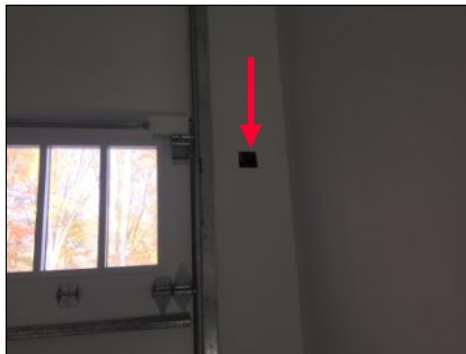
Observations: Bay 1 has a hole in the wall which needs repair to maintain fire rating.

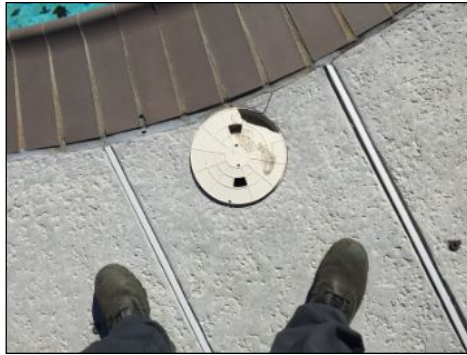
Pool skimmer cover is broken and needs replacement.

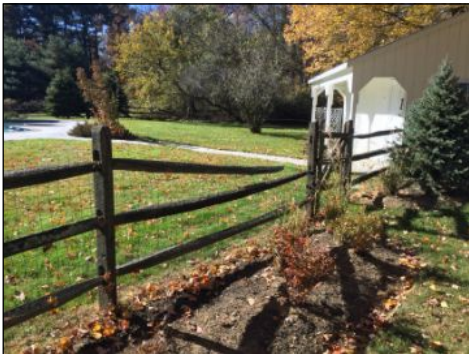
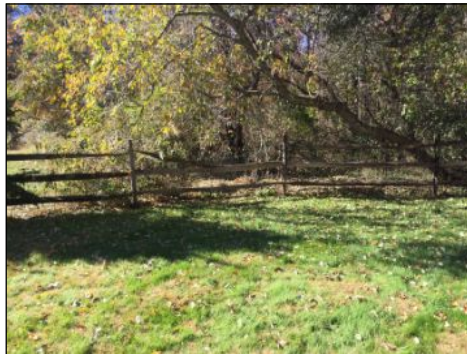
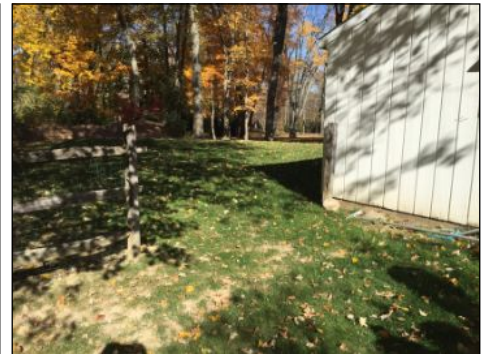
Areas of the fencing are incomplete and damaged which need repair.

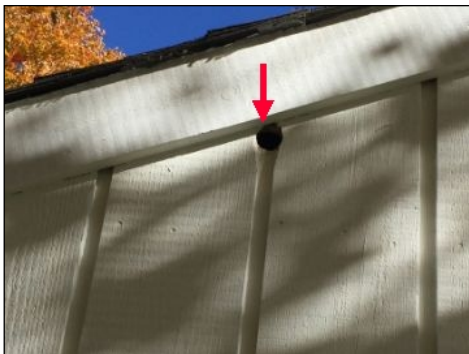
There are holes from wood peckers which need repair.

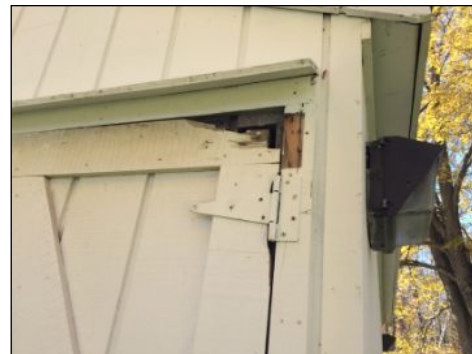
Exterior doors have rot and deterioration which need repair or replacement.
