Independent Home Inspection LLC

Building Inspection Report

1 Main Street, Anytown, NY 12540
Inspection prepared for: John Jones
Date of Inspection: 3/27/2015 Time: 10 AM
Age of Home: 1930 Size: 1500
Weather: 40's Partial snow cover

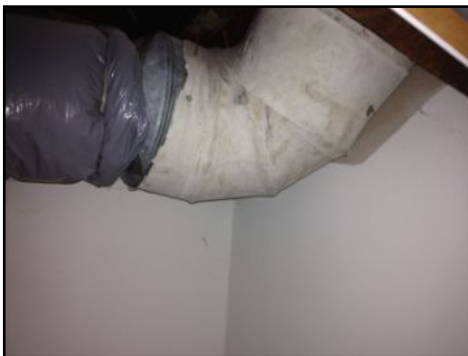
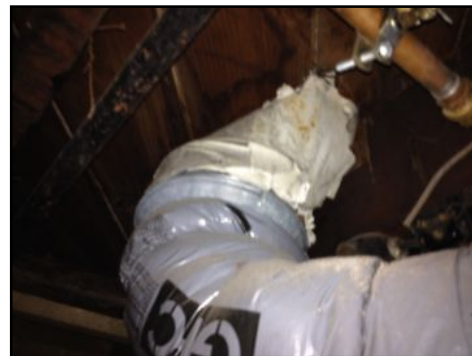
Observations: There is some remaining asbestos like ducting insulation noted, recommend testing to determine presence and possible removal by asbestos abatement contractor.

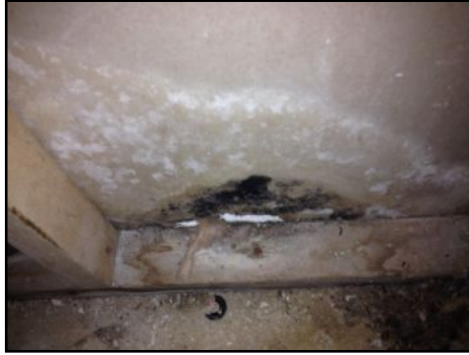
Observations: The walls in the basement have some mold like growth in prone areas which appears to have resulted from of elevated moisture levels within the basement finished walls against the foundation, All molds flourish in a damp environment and many are commonplace, but some are toxic and represent a health threat, recommend consulting a mold specialist for further evaluation, testing, and or remediation.

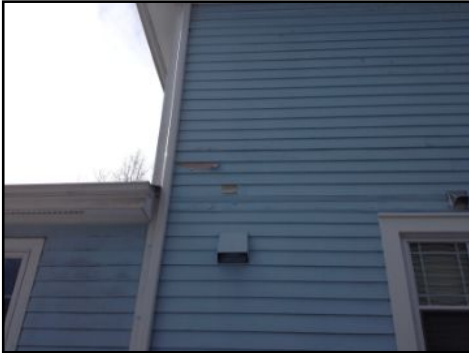
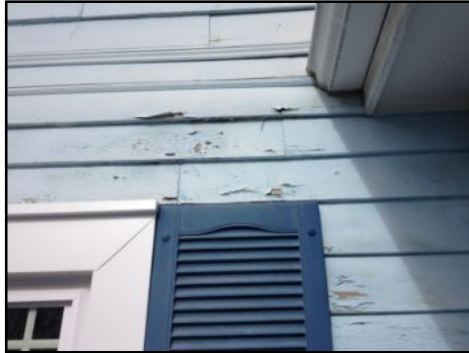
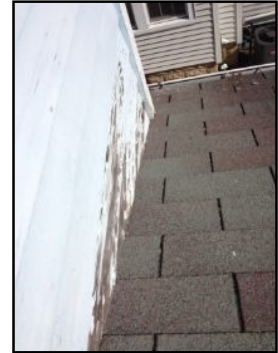
Observations: The wall covering will need surface prep and a finish applied to maintain integrity. Finish is peeling at prone areas.

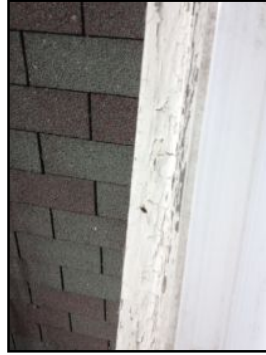
Observations: Wood sections of window trim and frames will need a finish applied to maintain integrity.

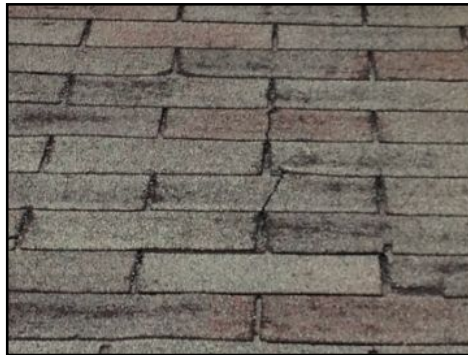
The roof surface has loss of aggregate and brittleness noted which indicates the surface is wearing. This means that the roof should be inspected more frequently and monitored for leaks as the roof will need replacing in the near future. Areas appear to lack proper underlayment below shingles which should be installed when re roofing.

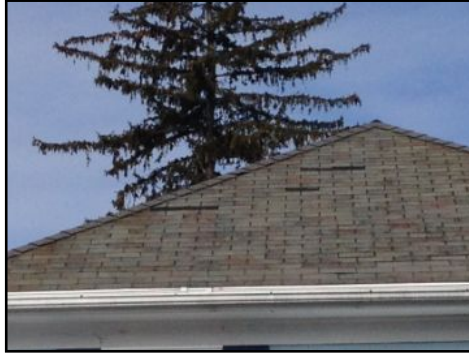
Observations: There are some damaged shingles which need replacement to ensure water tightness.
There are some missing shingles which need replacement to ensure water tightness.

There are some missing shingles which need replacement to ensure water tightness.

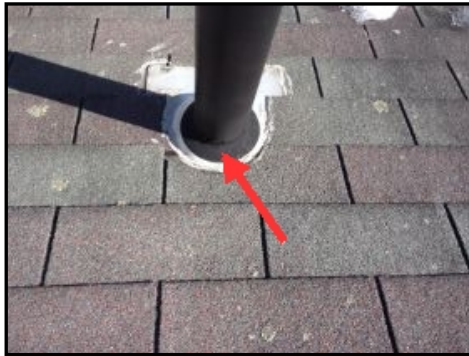
Observations: The vent pipe flashing rubber seal is cracked and deteriorated recommend repair or replacing flashing to ensure water tightness.

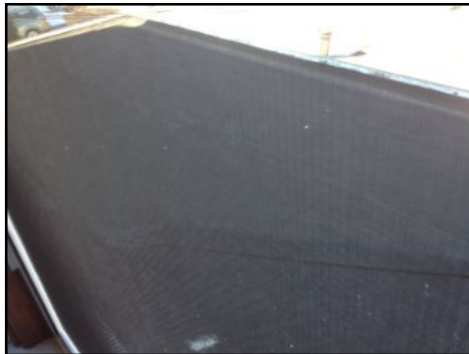
Observations: General condition of the roof covering appears functional with signs of weathering and aging appropriate to approximate age of roof.

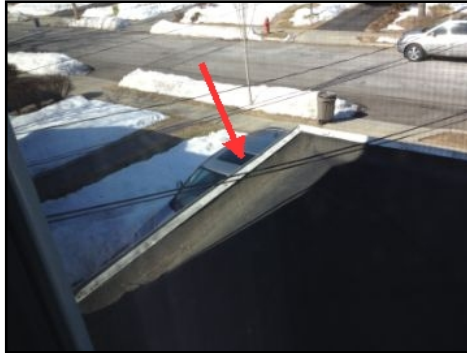
Observations: Drip edge flashing appears non professional with exposed fasteners which should be upgraded to ensure water tightness.

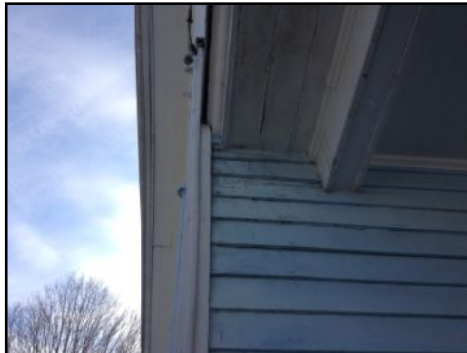
Gutters have evidence of ice damming which is conducive to water damage, recommend installing heating cable and or ice and snow removal as needed to ensure proper drainage. Porch roof drainage may need improvement to ensure proper drainage.

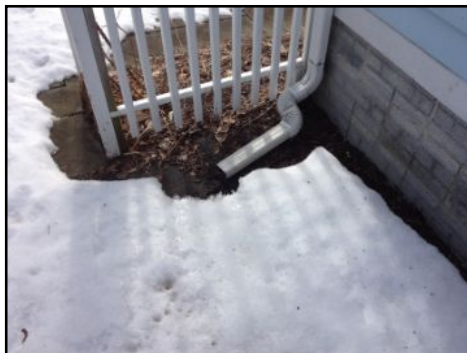
Observations: A few downspouts are dumping water next to the foundation which is conducive to moisture intrusion, recommend extending down spouts away from the structure, typically about six feet minimum, and installing a splash block to limit erosion.

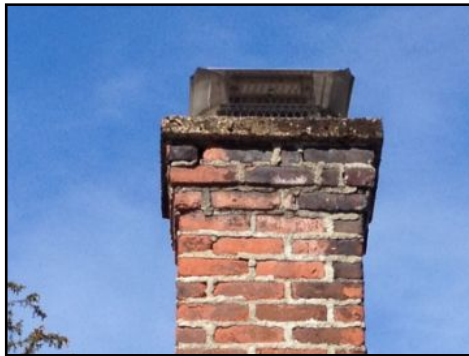
The mortar and some bricks are deteriorated which need to be repaired, raked, and re pointed at top portion of chimney above the roof line.

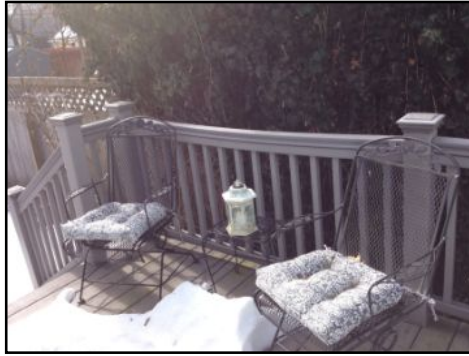
Guardrail between posts have sagging and needs additional support to maintain integrity.

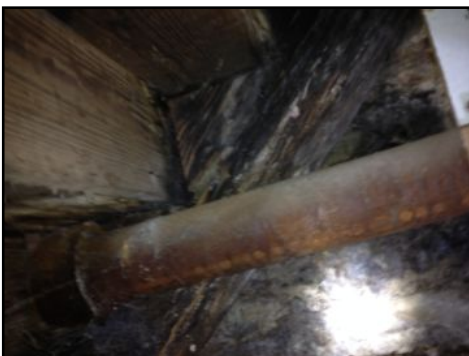
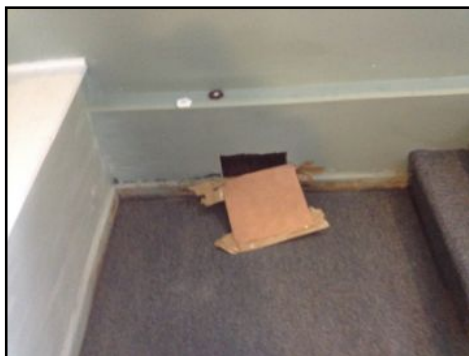
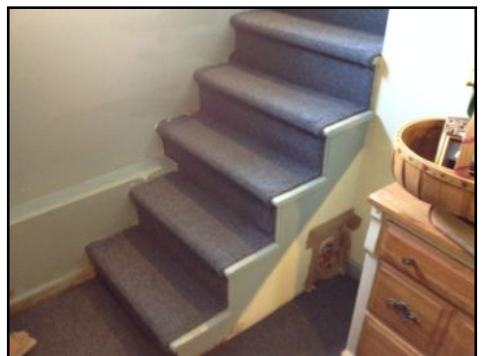
Observations: The foundation is allowing moisture intrusion which has resulted in rotted stairway stringer and steps, moisture damaged floor covering, wall covering, trim, and mold like growth which need repair and or replacement.

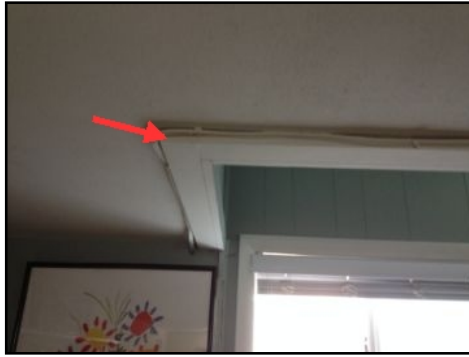
There is exposed wiring which is conducive to damage and is a safety hazard which should be repaired by electrician to include conduit for protection.

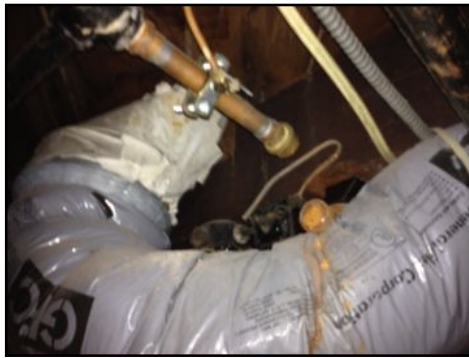
Hose spigot plumbing is disconnected and needs repair.

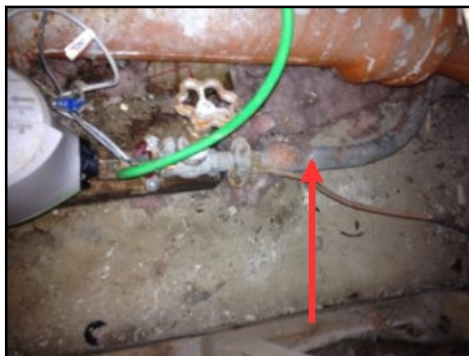
Lead piping is present and water should be tested for lead and monitored, recommend consulting filtration contractor for activated carbon filter.

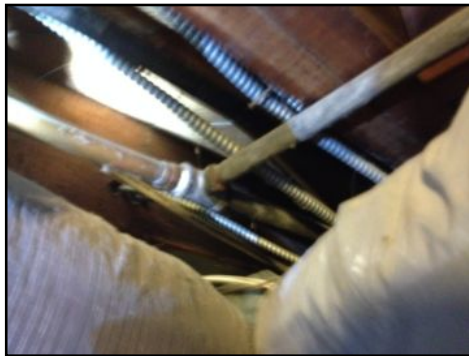
There are some remaining water pipes within this residence that are galvanized, and assumed to be original. They may produce rusty looking water from time to time and, because the water volume in such pipes will gradually be reduced by a build up of minerals within them, we do not endorse them and should be upgraded. Some accessible sections are replaced.

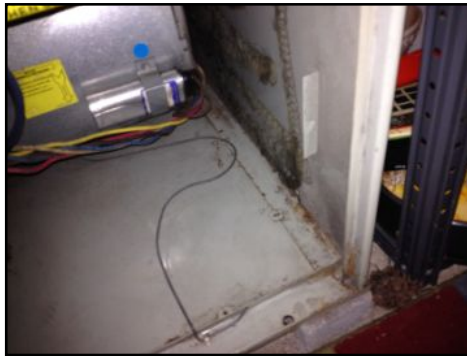
Acoustical lining within the air handler is missing and needs repair.

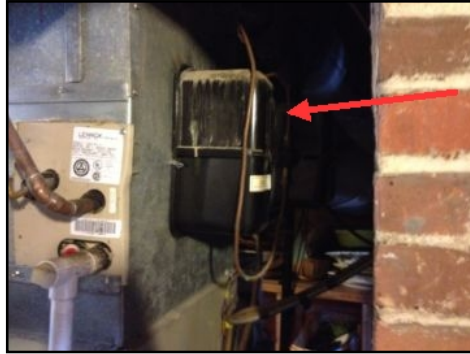
Observations: There is a humidifier which is off that should be serviced by heating contractor to ensure air quality and then activated for winter to supply moisture to indoor air.

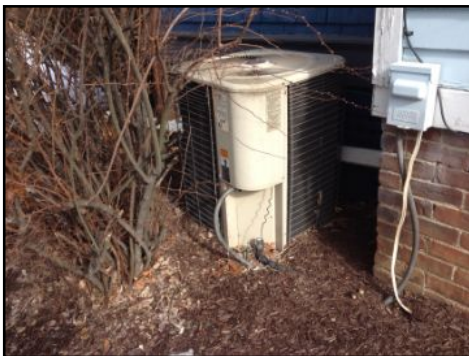
Grading is over base of condenser which needs clearance created to prevent condition conducive to deterioration.

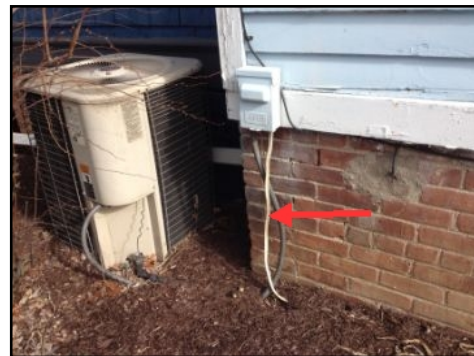
Electrical serving condenser is exposed and needs water proof conduit and connectors.

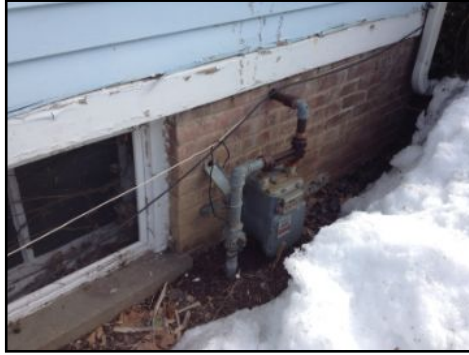
Recommend applying a finish to piping to maintain integrity and prevent rust staining.

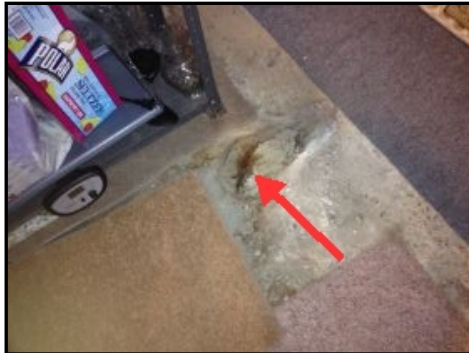
Abandon oil line noted near heating system indicating a possible buried or removed oil tank, recommend consulting owners for history of previous oil tank. If tank is or was buried recommend further evaluation and testing by tank specialist.

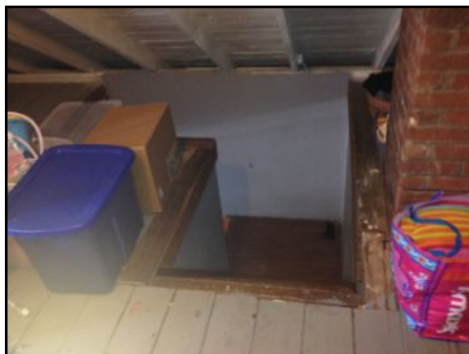
Guardrail needed at stairway opening in the attic for safety.

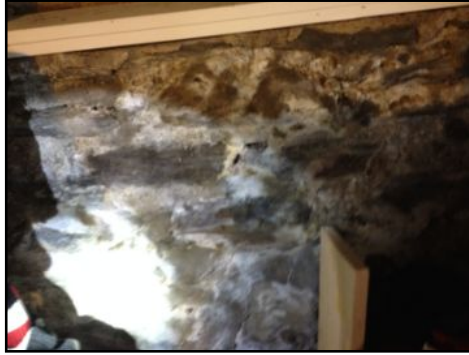
The basement could be subject to moisture intrusion, and the presence of salt crystal formations and staining on the basement walls and floor confirms that some moisture does reach this area. Therefore, you should keep any storage items isolated from the walls and floor, monitor the basement during heavy rains.

Recommend cleaning efflorescence, surface prep, and sealing foundation walls with masonry water proofing finish to prevent capillary moisture intrusion.

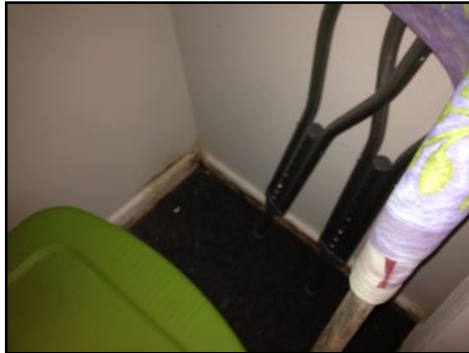
The exterior walls of the foundation appears to be allowing moisture intrusion which is evident from mold like growth, recommend creating further access for evaluation and repairs to ensure water tightness.
