Independent Home Inspection LLC

Building Inspection Report

1 Main Street, Anytown, NY 12540
Inspection prepared for: John Jones
Date of Inspection: 3/27/2015 Time: 10 AM
Age of Home: 1930 Size: 1500
Weather: 40's Partial snow cover

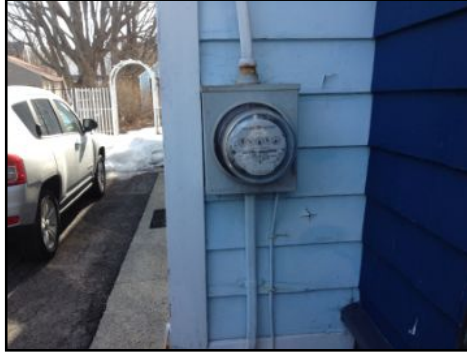
Electrical Service Meter Pan

Observations: Meter pan is functional condition.

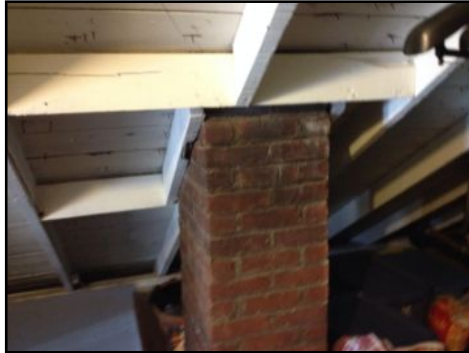
Framing Type: Rafters

Observations: The integrity of the visible portions of the roof framing are in functional condition.
