Independent Home Inspection LLC

Building Inspection Report

123 Sample Road, Bedford Hills, NY 10507
Inspection prepared for: John Smith
Date of Inspection: 10/31/2015 Time: 1 PM
Age of Home: 2014 Size: 8406
Weather: 60s sunny

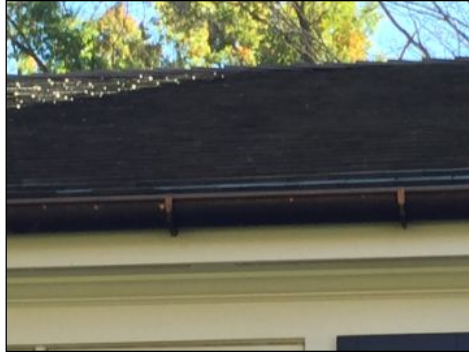
Observations: General condition of the roof covering appears functional with signs of weathering and aging appropriate to approximate age of roof.

Roofs are designed to be water resistant not water proof and require frequent maintenance on a consistent basis. Look for lifted fasteners, damage or broken shingles, and missing shingles from wind damage.

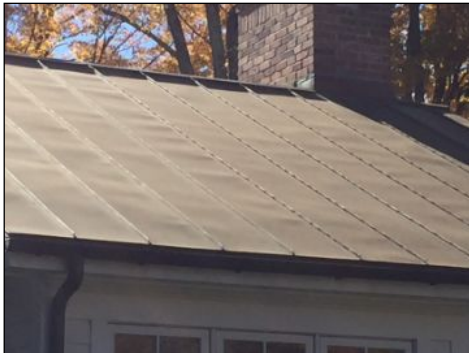
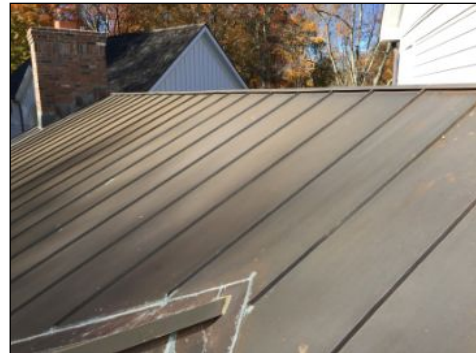
Type: Standing seam metal panels

Observations: General condition of the roof covering appears functional with signs of weathering and aging appropriate to approximate age of roof.

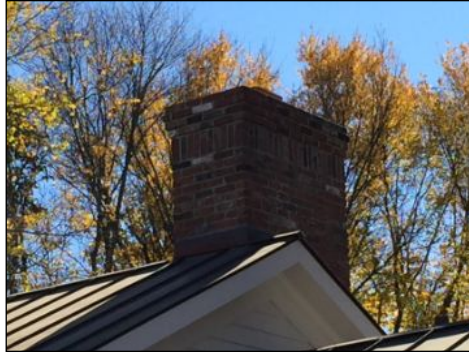
Observations: The visible portions of the chimney appear functional with some weathering.

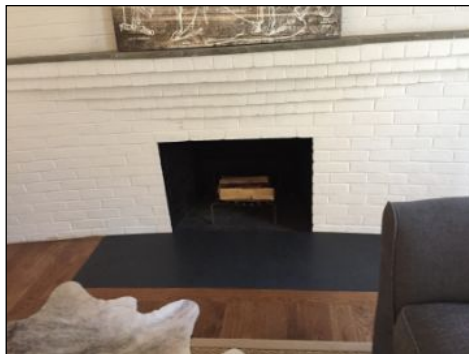
Fireplace

Observations: Wood burning fireplace is present.
Visible portions of the fireplace appear functional but not fire tested.

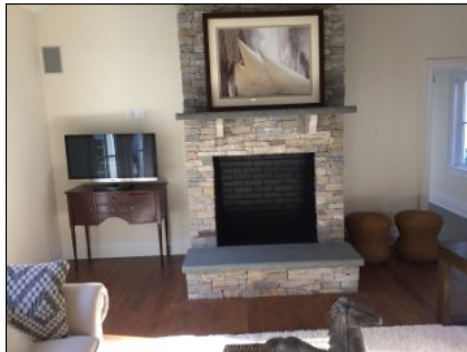
Observations: Wood burning fireplace is present.

Visible portions of the fireplace appear functional but not fire tested.

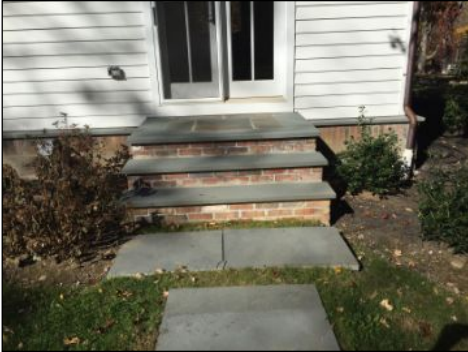
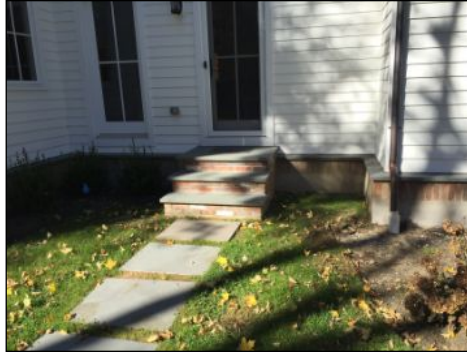
Handrail

Observations: Stairways lack handrails which should be installed.

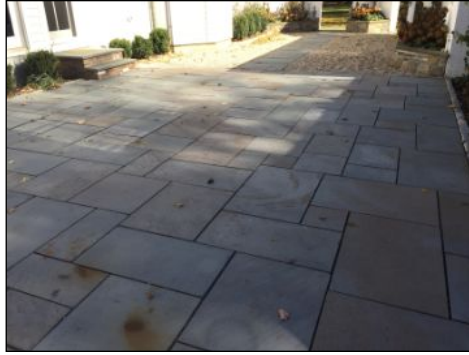
Observations: The patio is in functional condition.

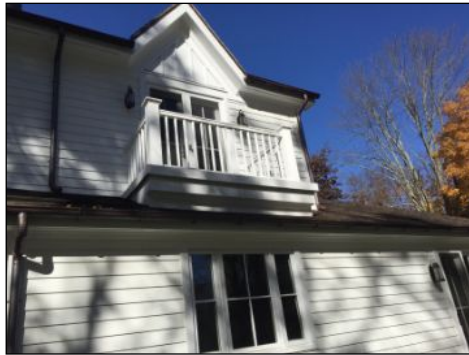
Observations: Balcony appears functional.

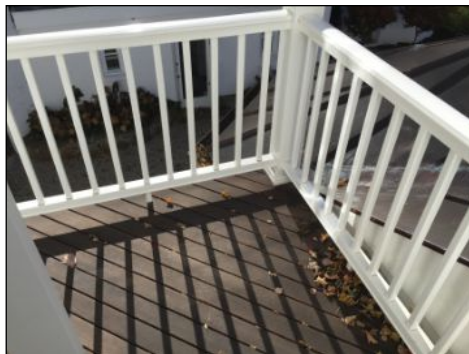
Observations: Balcony appears functional.

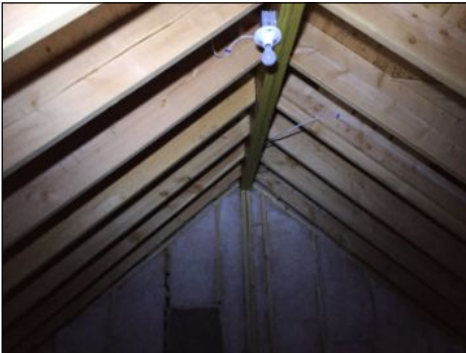
Observations: The integrity of the visible portions of the roof framing are in functional condition.

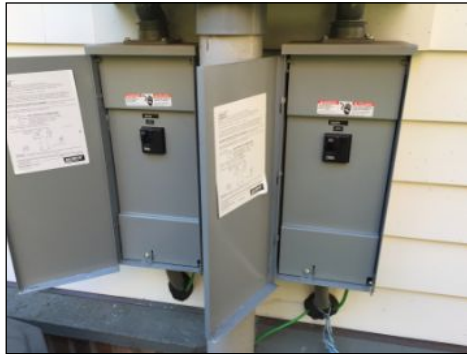
Observations: Visual components of the electrical service are in functional condition

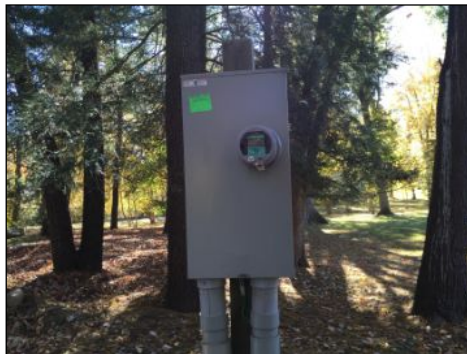
Electrical Meter Pan

Observations: Meter pan is functional condition.

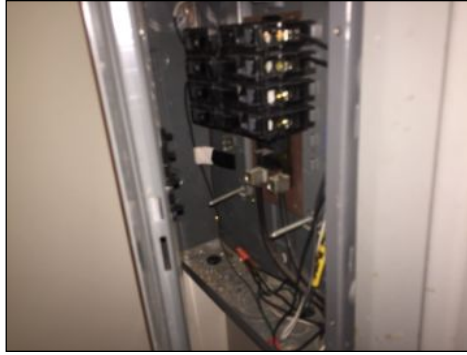
Sub Panel 2

Observations: Panel appears functional.

Over current protection devices are breakers.

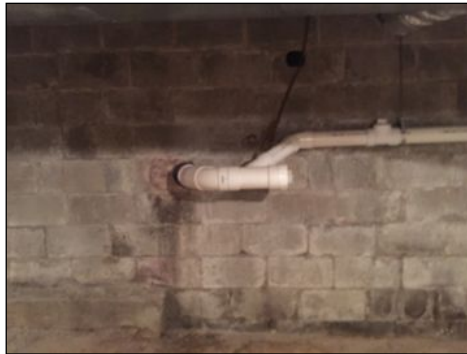
Observations: The visible interior waste lines appear functional.
Waste lines not fully visible.

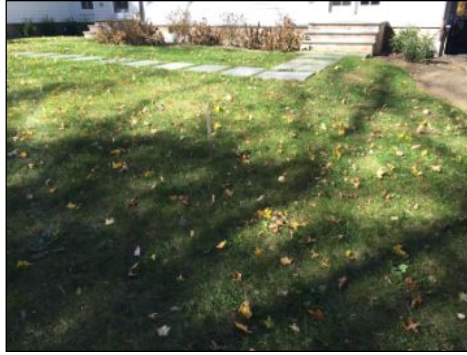
Treatment Tank

Observations: Recommend pumping tank for maintenance every 3 to 5 years or as per size of tank verse number of people living in structure. This will allow for a visual inspection of tank interior by pumping company. If the tank has not been pumped according to chart it is recommend that a maintenance type pumping of tank be performed. The system would need access and pumping if system is to be further evaluated.

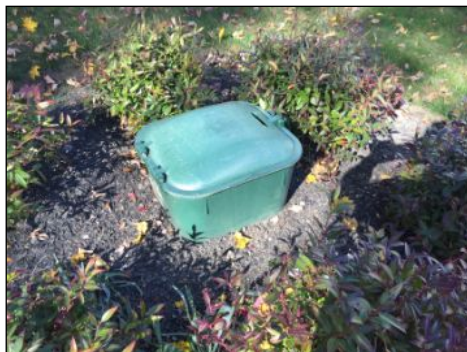
Propane Tank 2

Observations: Tank is buried unable to inspect.
Tank has propane stored.

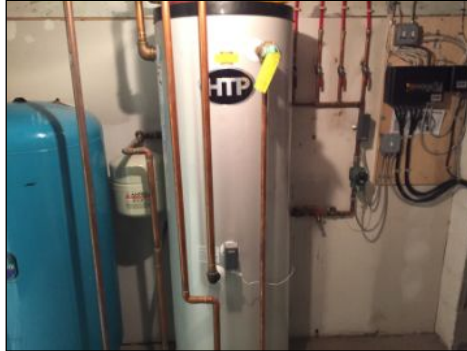
Observations: Hot water heater is functional.

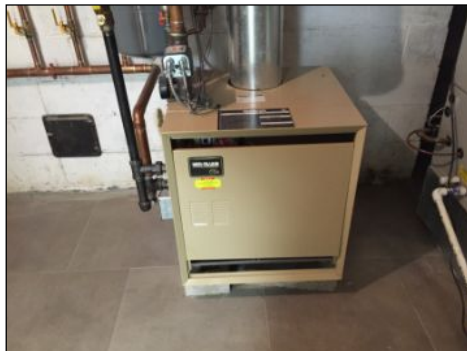
Observations: Heating system was tested by activating with the use of the thermostat which activated at time of inspection.

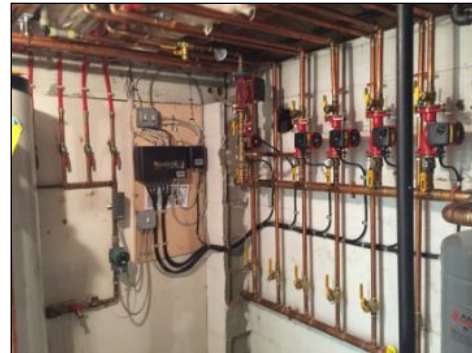
Distribution Type: Hot water coils within the air handlers, Radiant floor bathroom

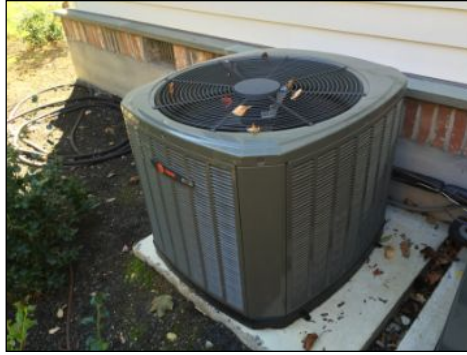
Observations: Air conditioning system was tested by activating with use of the thermostat which activated and cooled the air at time of inspection.

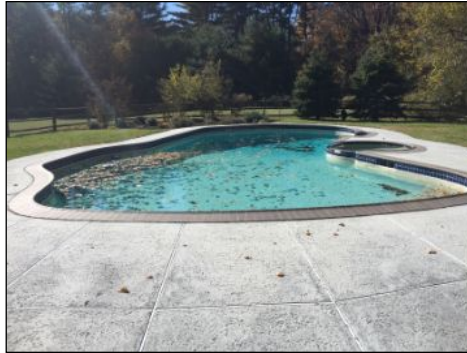
Observations: Pool appears in functional condition with some weathering.

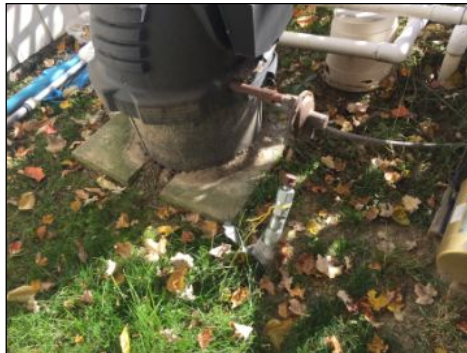
Observations: Pool water heater fuel supply is disconnected which needs evaluation, activation, and servicing to confirm unit is functional.

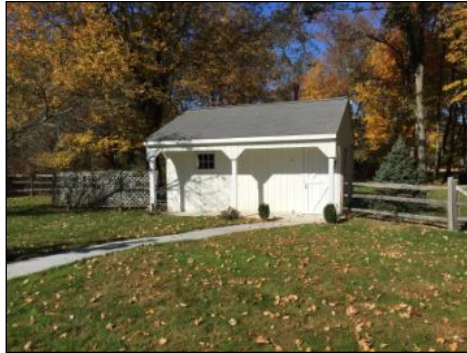
Observations: General condition of the roof covering appears functional with signs of weathering and aging appropriate to approximate age of roof.
